11 April 2016

Project 151186.01 – Department of the Works Building, 7 Water Street, Millis, MA

Project 151186 – Leakage Investigation, Department of the Works Building, 7 Water Street,
Millis, MA

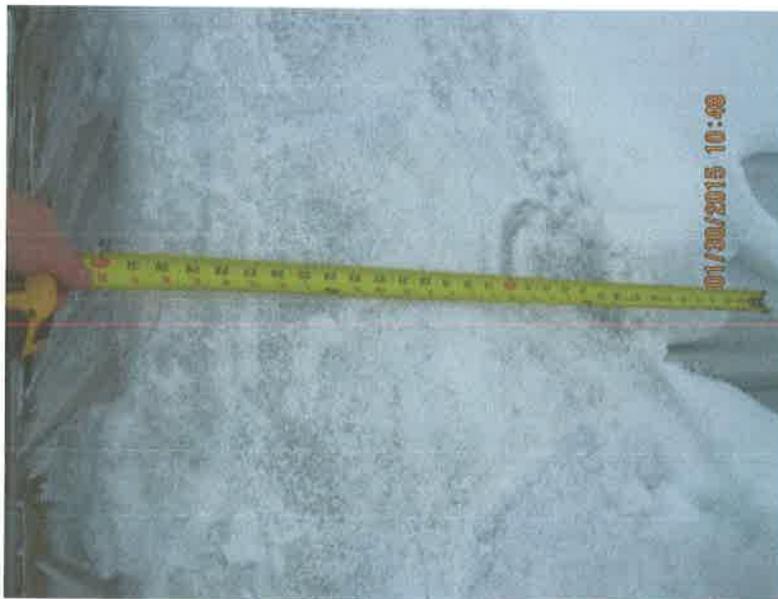
Photo 2

We visited the site on 30 January 2015 and observed ice dams (Photos 2 and 3) along both building eaves with icicles spanning and covering sections of the wall (Photo 4). We observed melting areas on the roof above purlins (Photo 5) and at areas in the field of the corrugated panels (Photo 6). We also observed ice and moisture on the interior of the corrugated metal panels at damaged insulation areas on the walls and the roof (Photo 7). We discussed our initial observations with you to determine the following investigation scope of work.

Ice dam at eave edge.

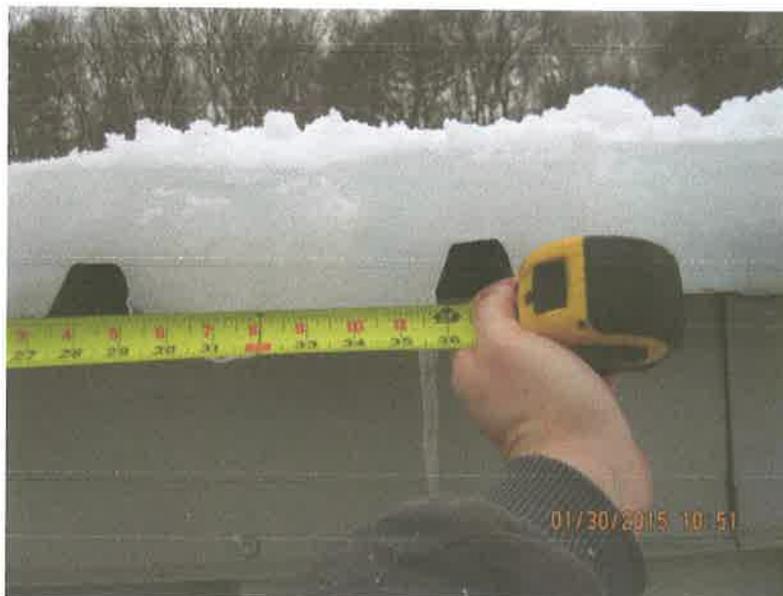
Photo 3

Ice dam at eave edge.

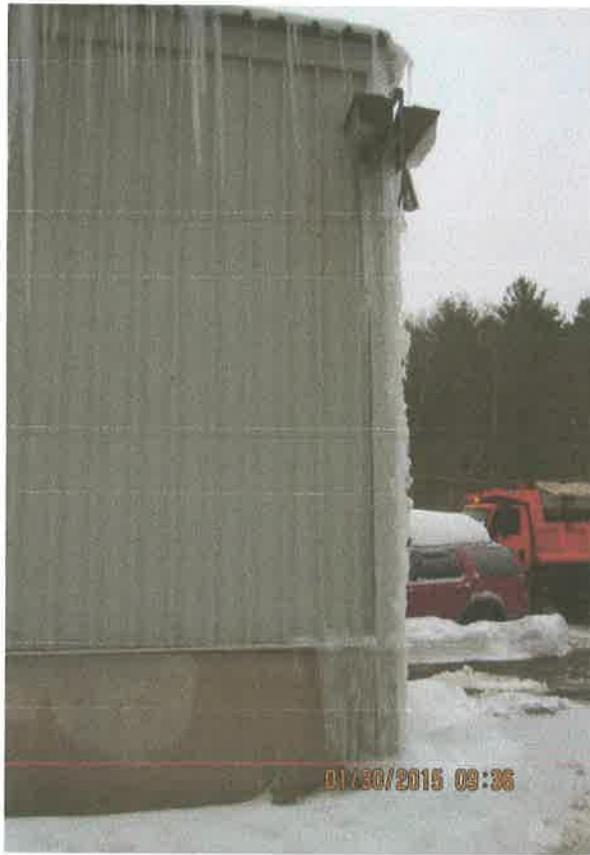
Photo 4

Ice dam transitions down face of wall.

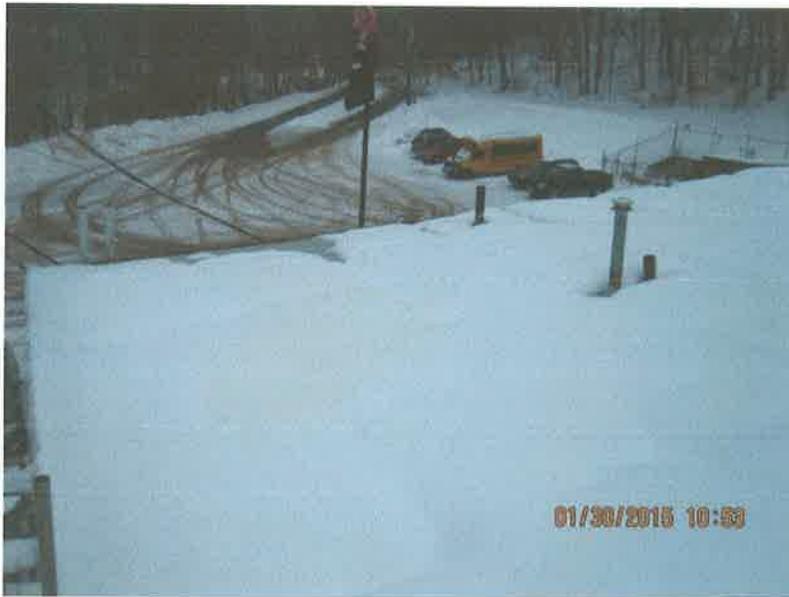
Photo 5

Snow melt above purlins.

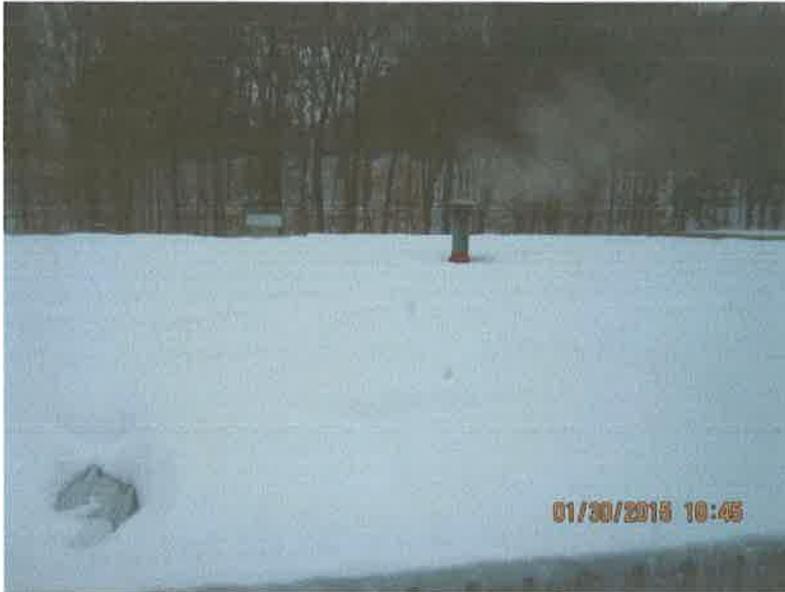
Photo 6

Snow melt adjacent to roof and wall transition.

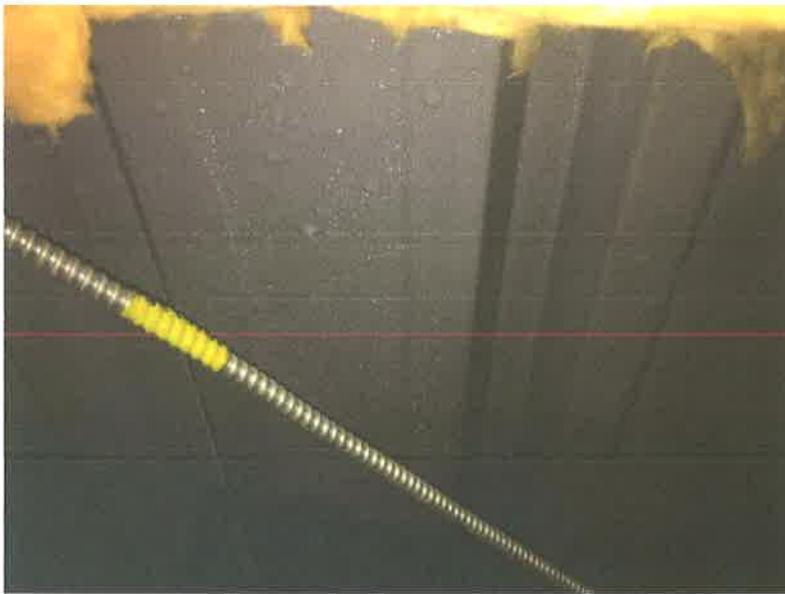
Photo 7

Condensation on the underside of the roof panel.

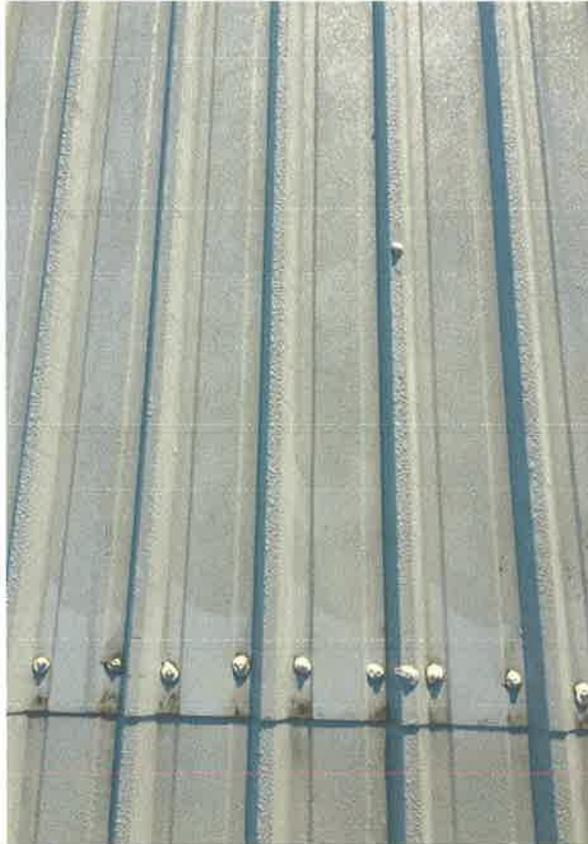
Photo 9

The roof panels are corrugated metal that lap one corrugation at vertical seams; end laps at transverse joints are lapped 4 in. (Photo 9). We observed 1/8 in. thick by 1/2 in. wide butyl tape installed between laps in the vertical and transverse panel joints (Photo 10). The fasteners compress the butyl tape at those locations; at locations between fasteners we observed no adhesion between the butyl tape and the upper/lower corrugated panels (Photo 11). The corrugated panels overhang the wall approximately 5 in. at the eave-to-wall transition (Photo 12). The eave-to-wall transition is filled with rigid insulation (Photo 13).

Typical roofing joints.

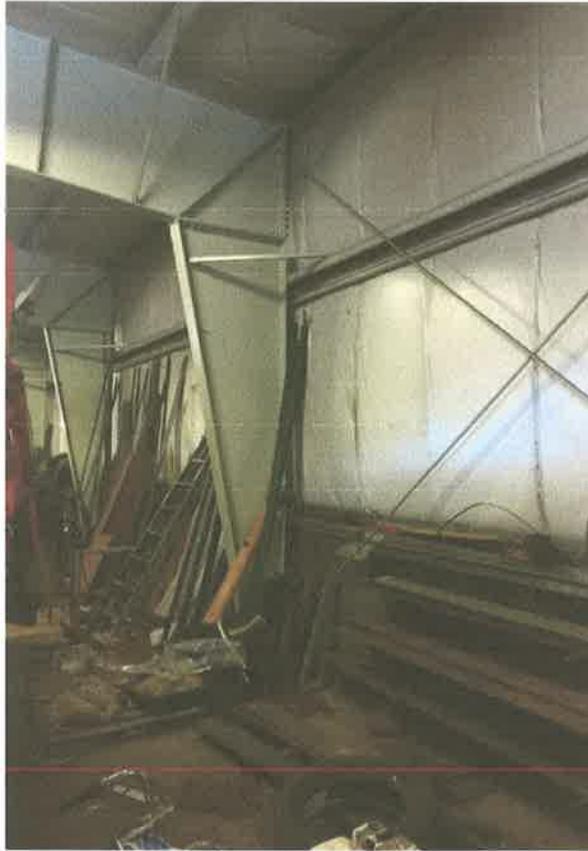
Photo 16

We observed multiple holes in the insulation facer where equipment and tools lean against the building walls (Photo 16).

Equipment stored against the vinyl faced batt insulation.

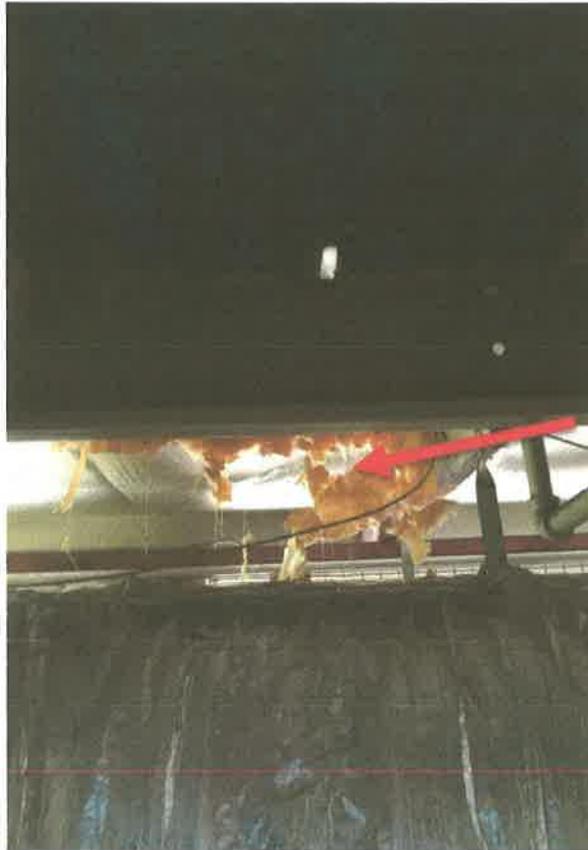
Photo 18

We performed a flood test of transverse and vertical seams in the metal roof panels to replicate probable conditions during ice dams. We created a pond of water over vertical and horizontal seams as well as over fastener locations. Water immediately leaked to the interior during our test (Photo 18).

During our ponding water test, we observed water bypass the butyl tape seal at the vertical seams and transverse laps in the metal panel roofing and leak to the interior. The butyl tape seal is not uniformly adhered to both the upper and lower corrugated panels. The lack of adhesion is the main source of water leakage to the interior. Installing a better butyl tape or a butyl sealant joint is one way to eliminate this leakage path by, but it would require removal and reinstallation of every roof panel. Installing new butyl tape or sealant will require adequate adhesion, which may be provided by the clamping action of the fasteners. Panel areas that are away from the fasteners will not have sufficient clamping to maintain adhesion. It is possible to include additional fasteners, especially along transverse laps; however, the roof will still rely on butyl tape and sealant joint to maintain water tightness.

Leak during flood test.

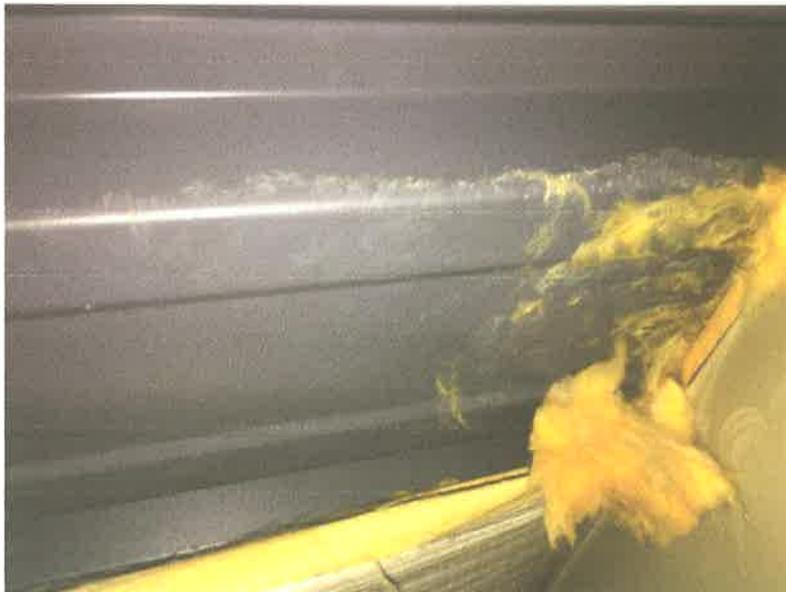
Photo 19

While installing the data loggers, we noted ice and frost on the underside of the metal panels. On cold enough surfaces, condensation can become frost and also build up to form ice. Once the frost or ice melts, either from the heating of the substrate or through the introduction of warm air, it creates a leakage-like event, and may eventually saturate the insulation.

Ice on the underside of the roof insulation.

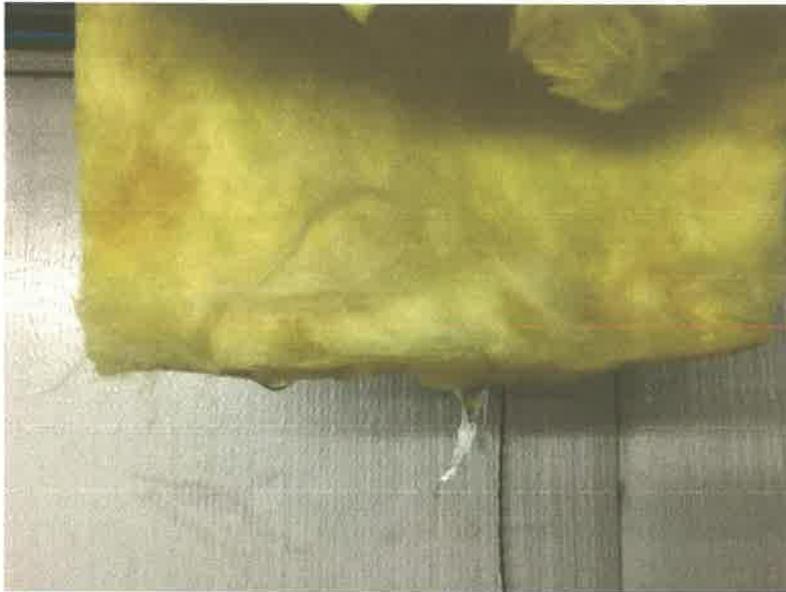
Photo 20

On 15 October 2015 we arrived on site at 7 a.m. to install temperature and relative humidity data loggers. The outside temperature was 39°F when we arrived. We made openings in the insulation above the mezzanine area to install two data loggers above the insulation. We observed ice on the underside of the roof panels (Photo 19). The roof insulation at the eave-to-wall transition was saturated with water (Photo 20) and began to drain to the floor while we made the opening.

**Saturated batt insulation at
Data Logger #1.**

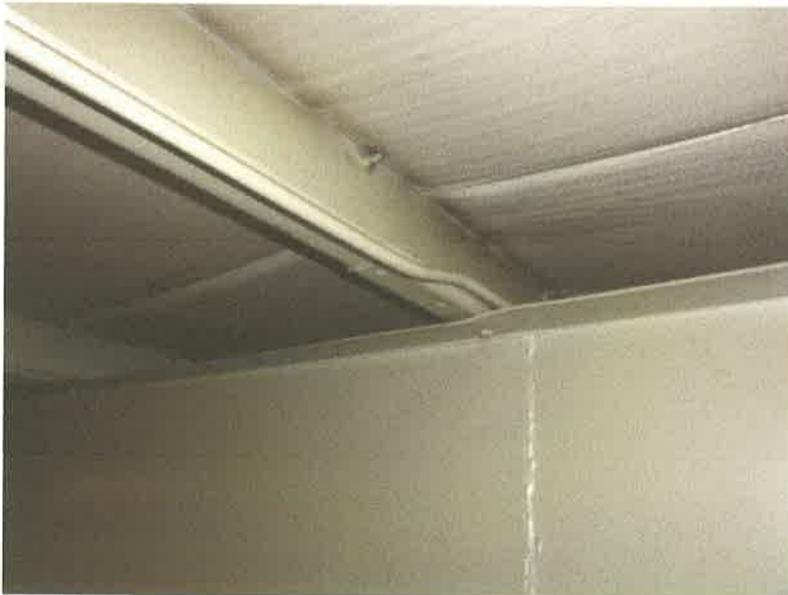
Photo 5

We observed a bend in the top flange of one of the bents (Photo 5).

Roof purlins are spliced longitudinally over the tops of bents. The top flange of the bent has a bent flange near the purlin connection.

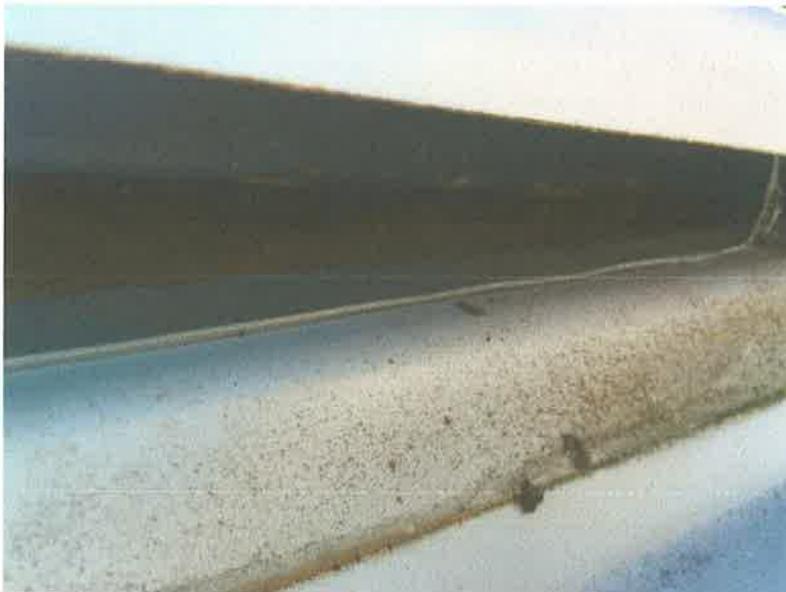
Photo 10

Butyl tape at vertical metal roof seam – not adhered.

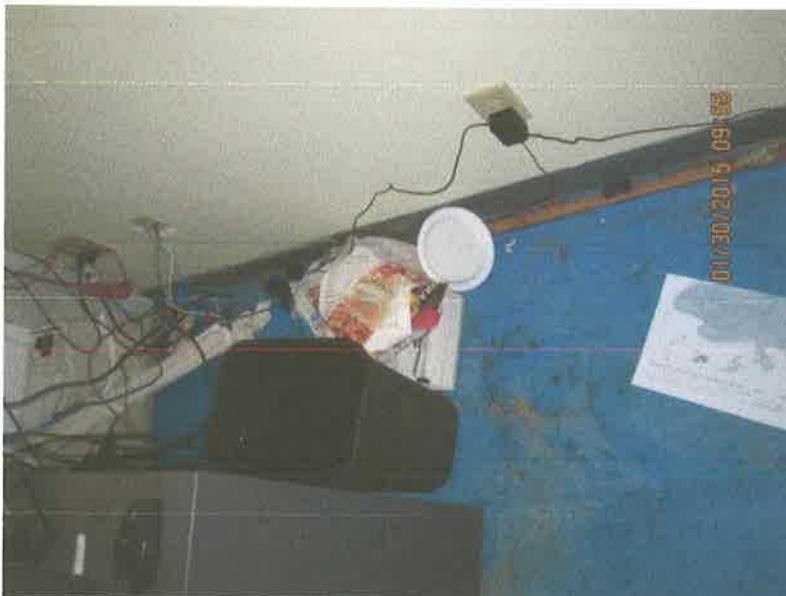
Photo 2

Office leakage area.

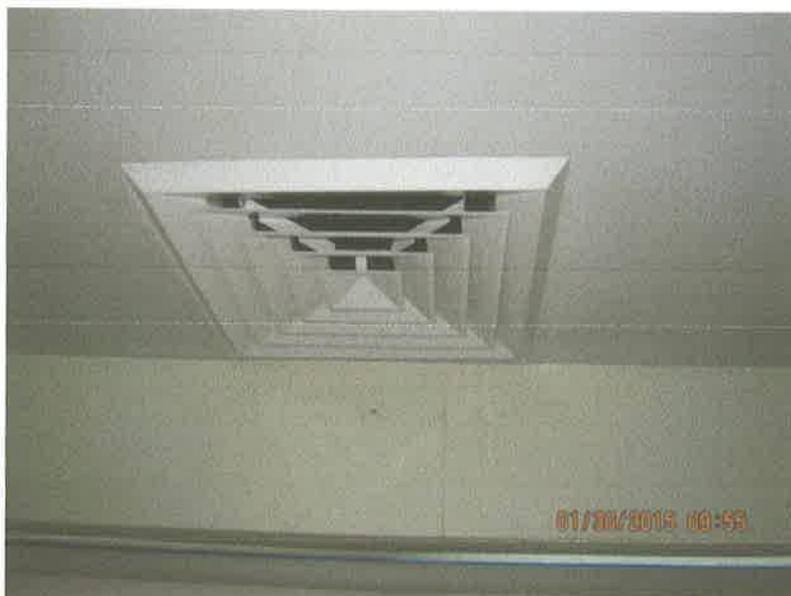
Photo 3

HVAC vent where leakage came through.

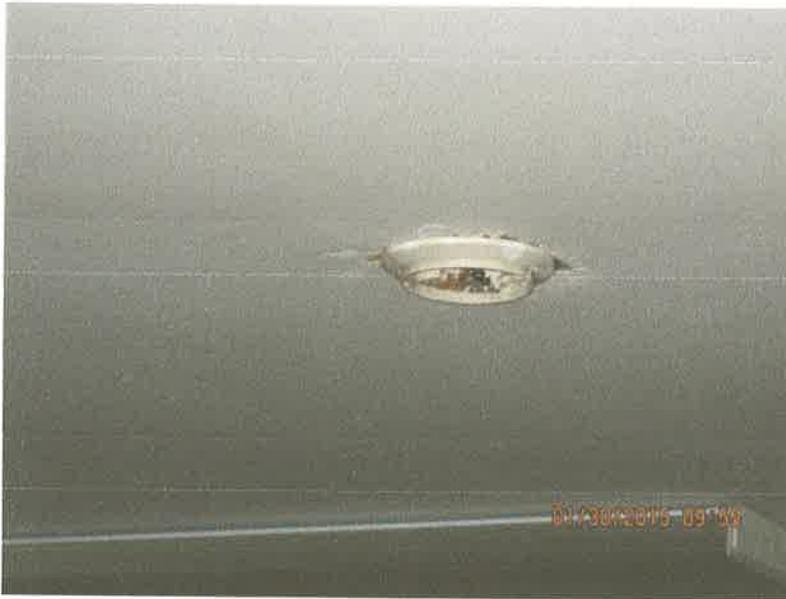
Photo 4

Smoke detector where leakage came through.

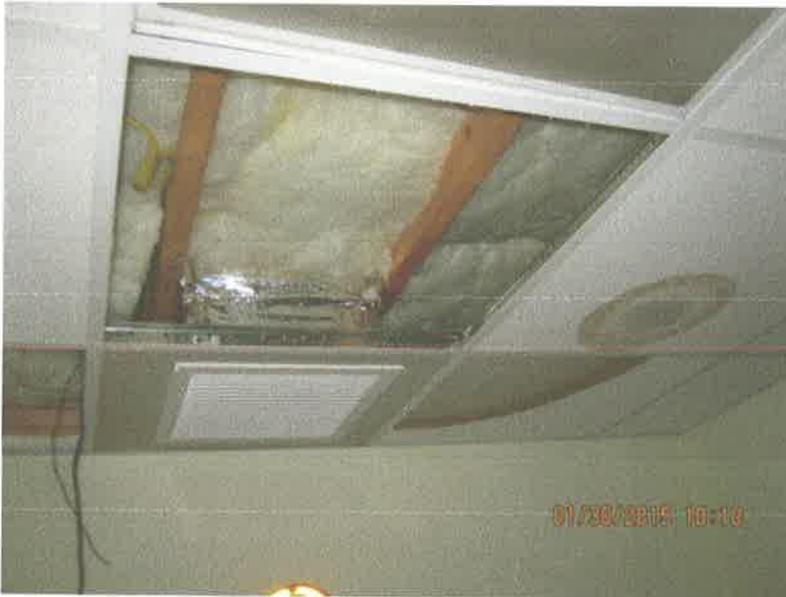
Photo 5

Mechanics area leakage at HVAC duct.

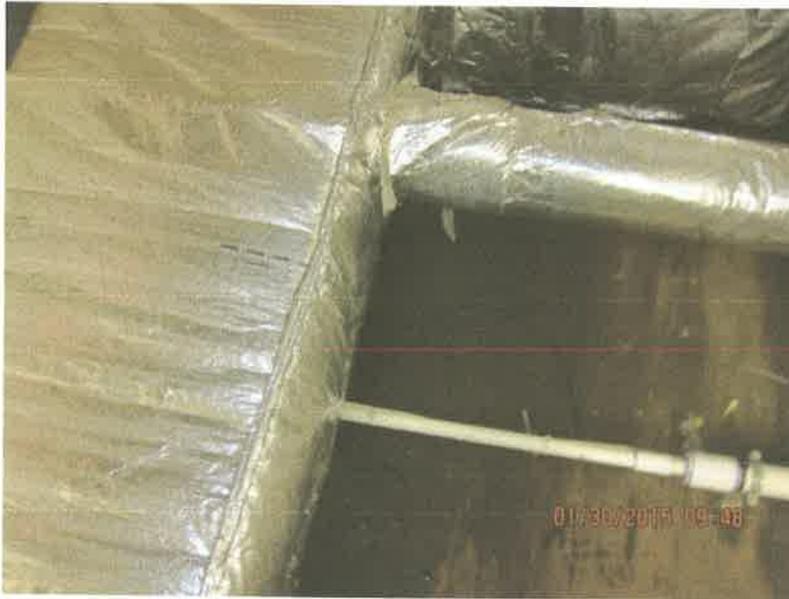
Photo 8

Wet loft area floor above office area.

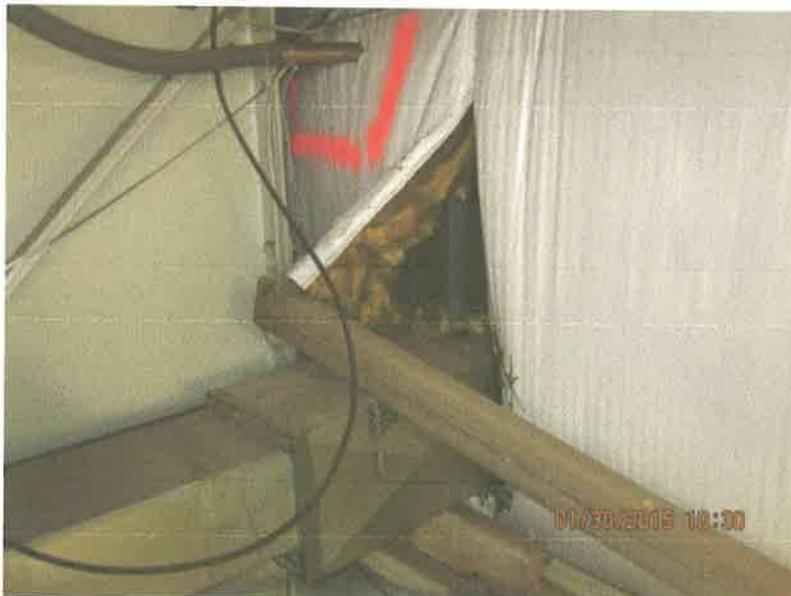
Photo 9

Open insulation at leak area above mechanics room.

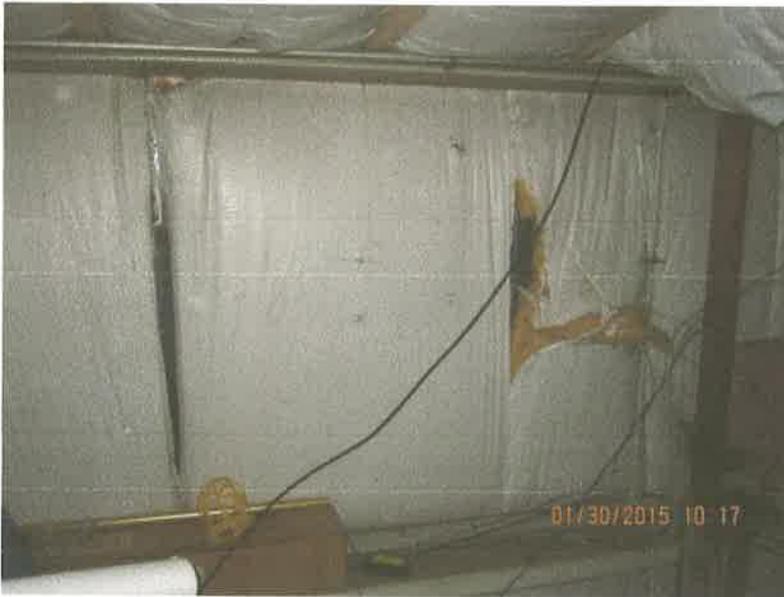
Photo 10

Wet metal panel and insulation.

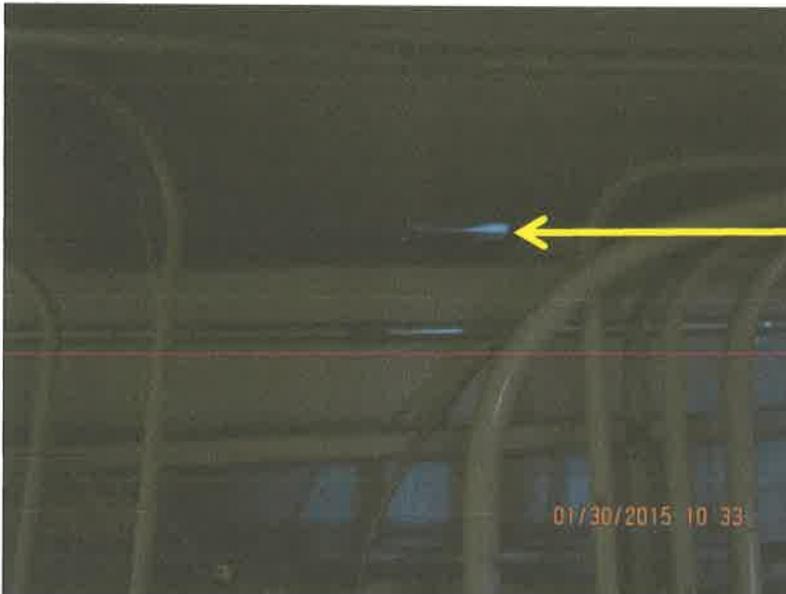
Photo 11

Daylight visible at wall-to-roof transition.

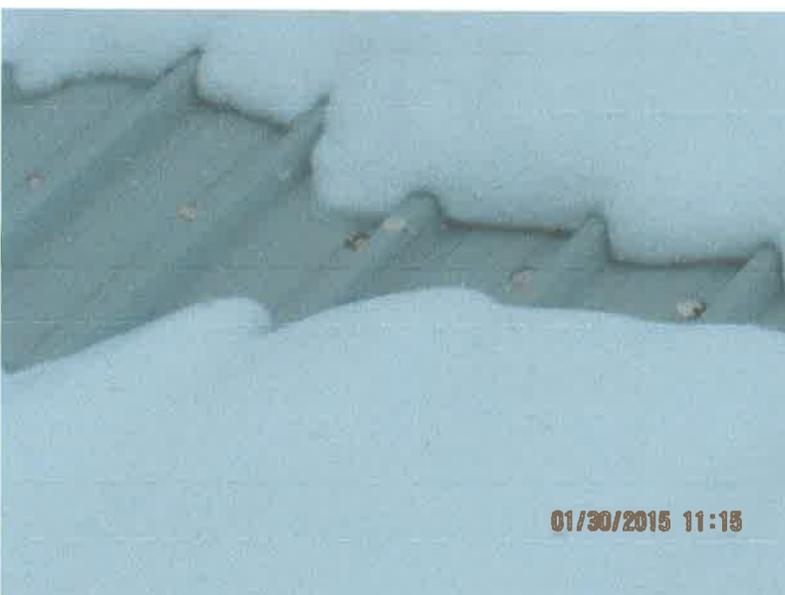
Photo 15

Face fasteners at corrugated metal roofing. Insulation below is open.

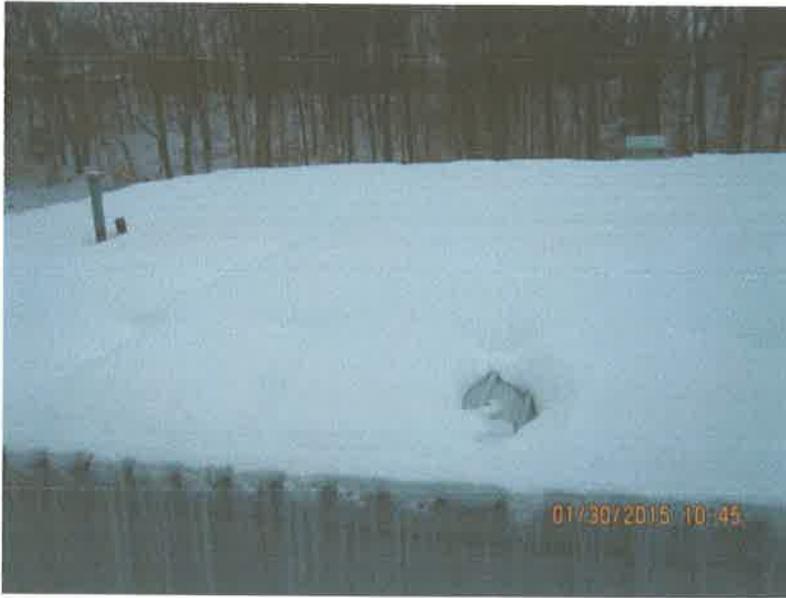
Photo 16

Melted snow above insulation gap.

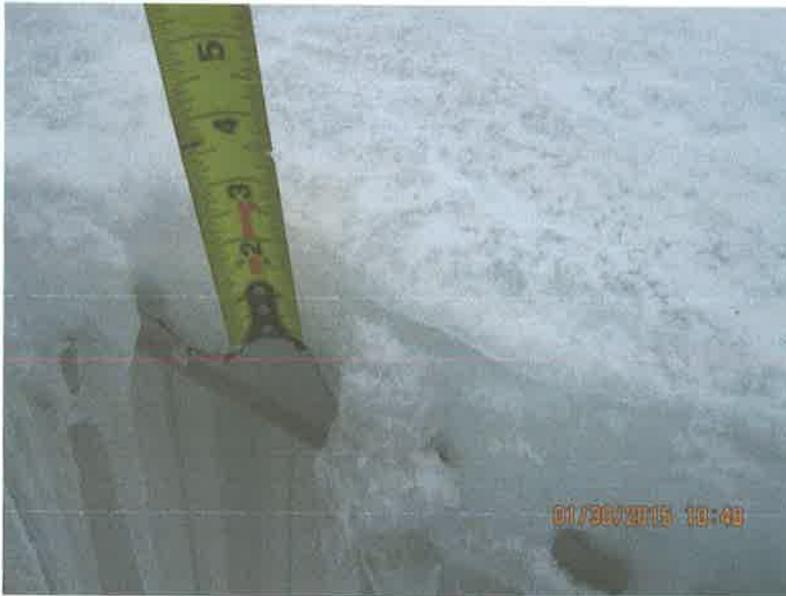
Photo 17

Ice dam at eave edge.

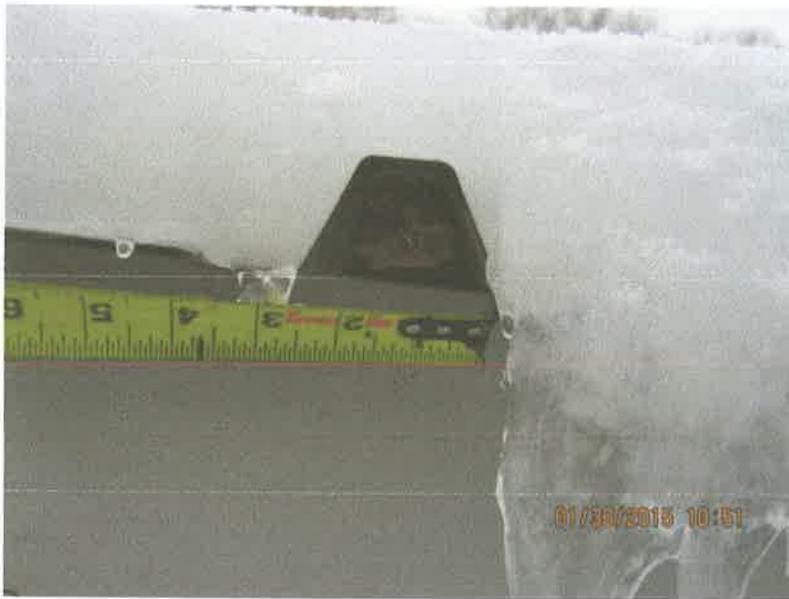
Photo 19

Water draining from ice dam.
