11 April 2016

Project 151186.01 – Department of the Works Building, 7 Water Street, Millis, MA

Project 151186 – Leakage Investigation, Department of the Works Building, 7 Water Street,
Millis, MA

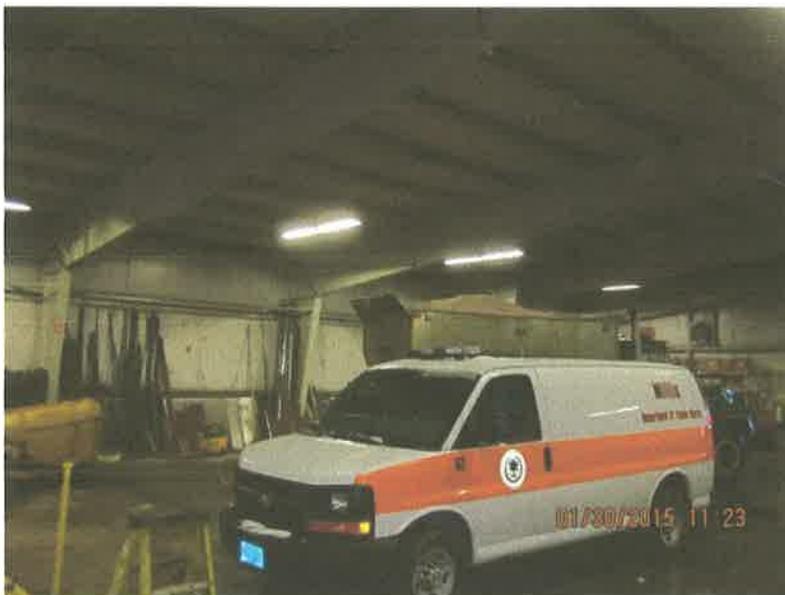
Photo 8

Open plan garage area.

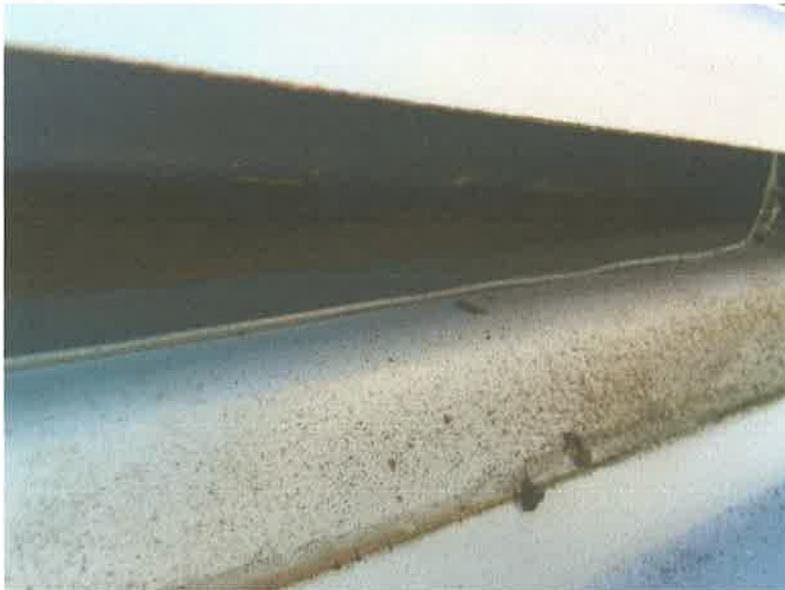
Photo 10

Butyl tape at vertical metal
roof seam – not adhered.

The roof panels are corrugated metal that lap one corrugation at vertical seams; end laps at transverse joints are lapped 4 in. (Photo 9). We observed 1/8 in. thick by 1/2 in. wide butyl tape installed between laps in the vertical and transverse panel joints (Photo 10). The fasteners compress the butyl tape at those locations; at locations between fasteners we observed no adhesion between the butyl tape and the upper/lower corrugated panels (Photo 11). The corrugated panels overhang the wall approximately 5 in. at the eave-to-wall transition (Photo 12). The eave-to-wall transition is filled with rigid insulation (Photo 13).

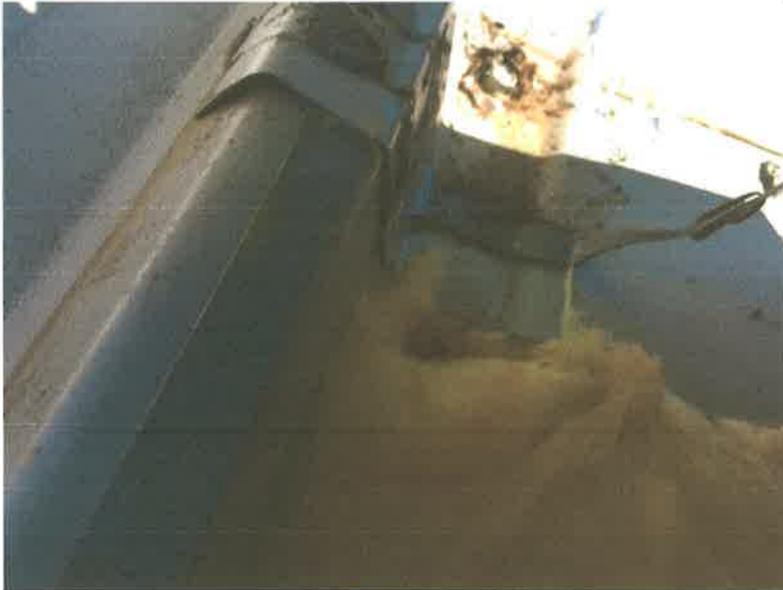
Photo 11

Butyl tape at transverse joint and vertical joint – not adhered.

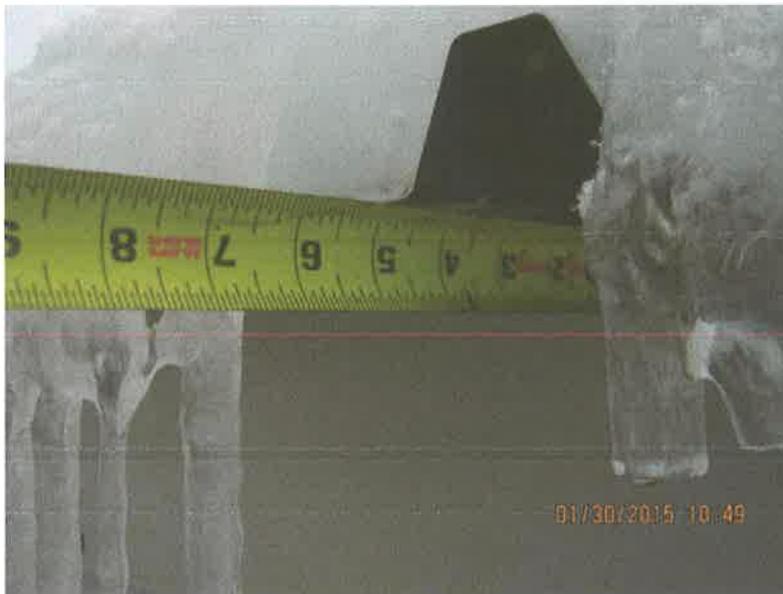
Photo 12

Corrugated roof panel overhang at the wall.

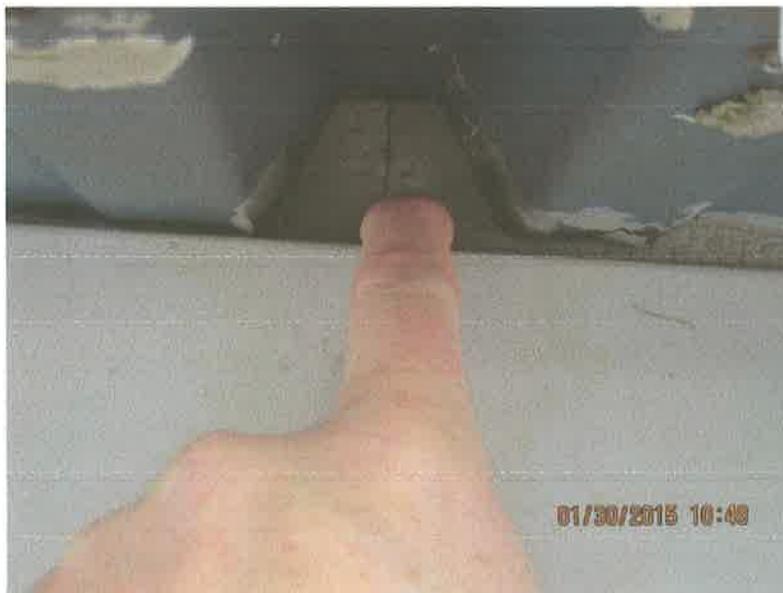
Photo 13

Insulation at the roof-to-eave transition.

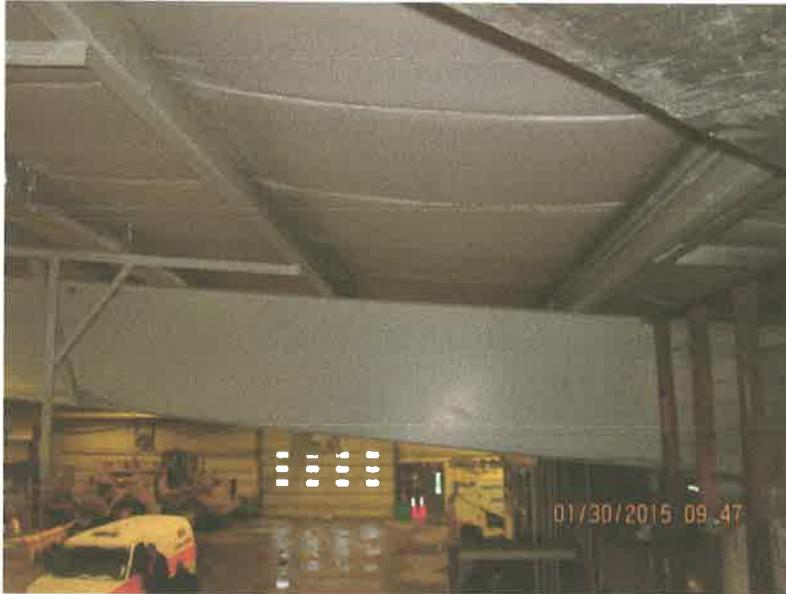
Photo 14

Vinyl faced batt insulation spans between purlins.

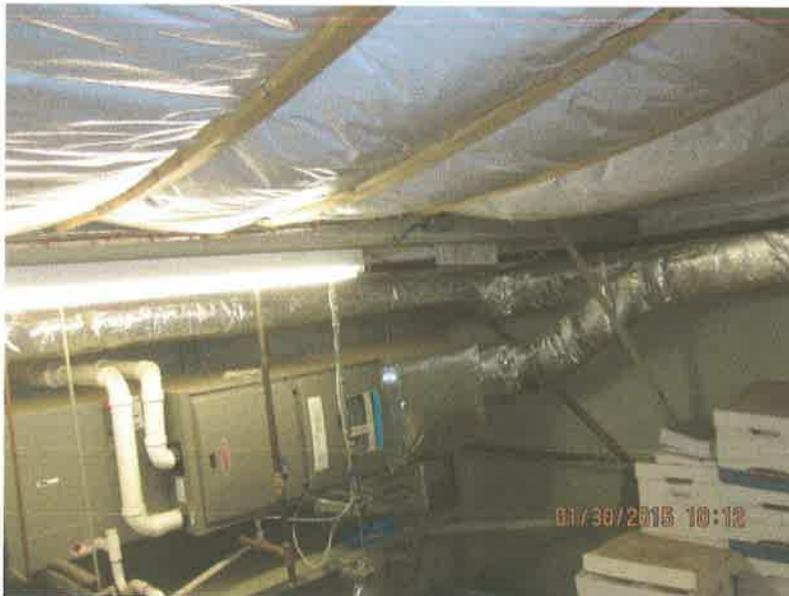
Photo 15

Vinyl faced batt insulation supported with wood strapping.

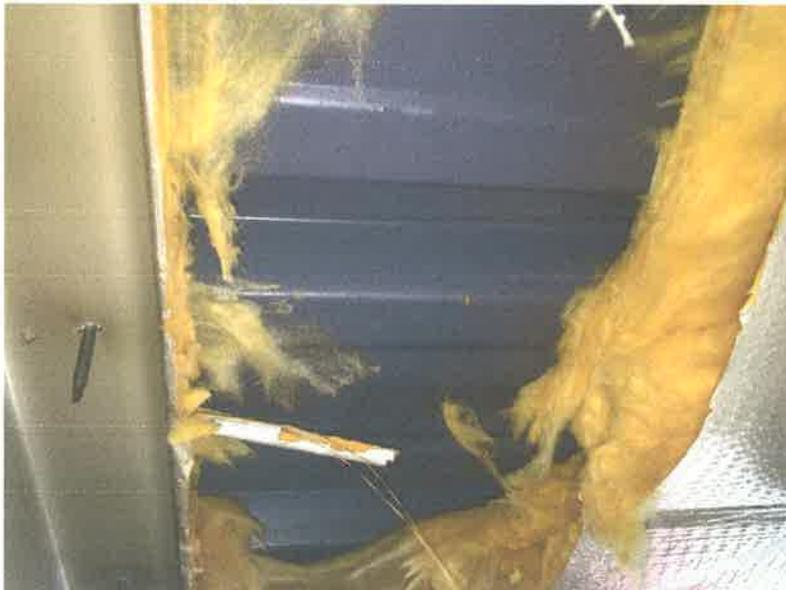
Photo 17

Condensation on the underside of the corrugated metal roof panel.

During the winter, condensing moisture on the underside of the roof forms a layer of ice. When the ice melts in milder weather or sunny conditions, water drips from the vinyl insulation cover and wets whatever is below.

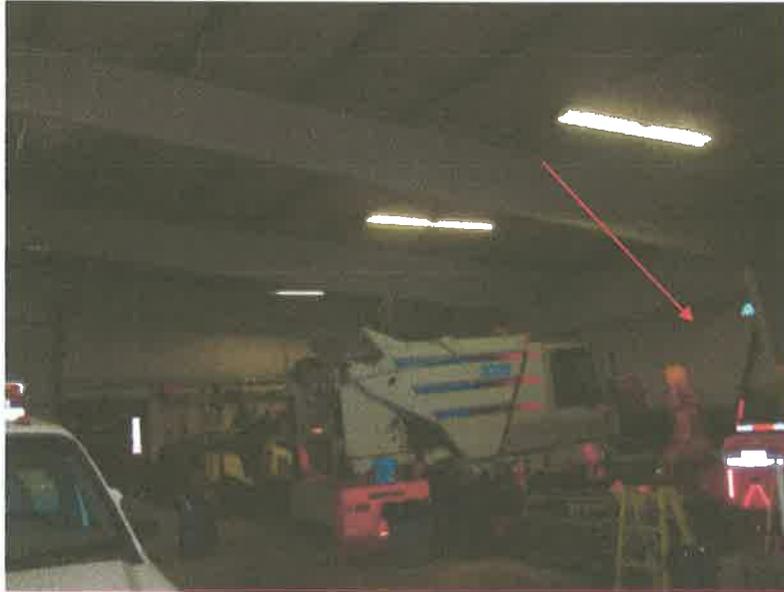
Photo 4

$\frac{3}{4}$ in. diameter cross-bracing (arrow) on the bents along gridlines B and C provide lateral load resistance.

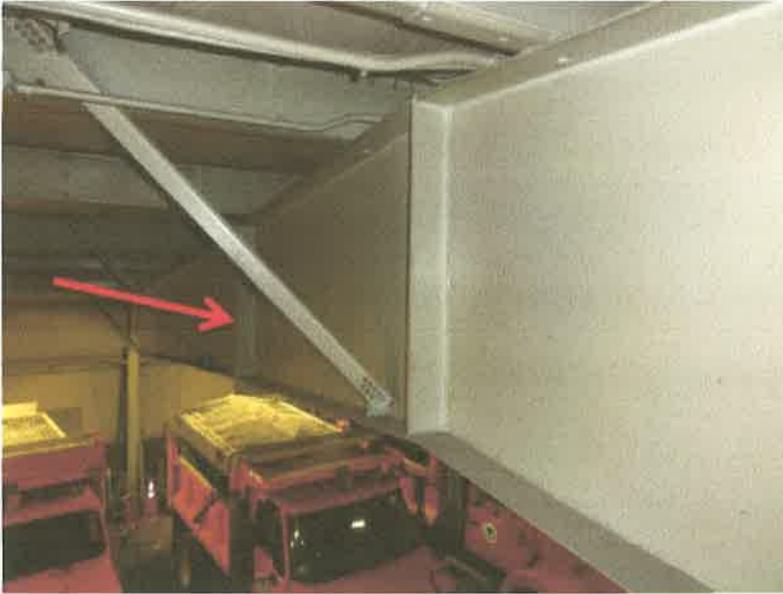
**Photo 10**

A double-pitched, built-up steel beam is spliced to each of the pitched members shown in Photo 9 at the mid-span of the bent. The splice plate is indicated by the red arrow. Also shown, the bottom flanges of the beams of the bent are braced by kickers to the roof purlins.

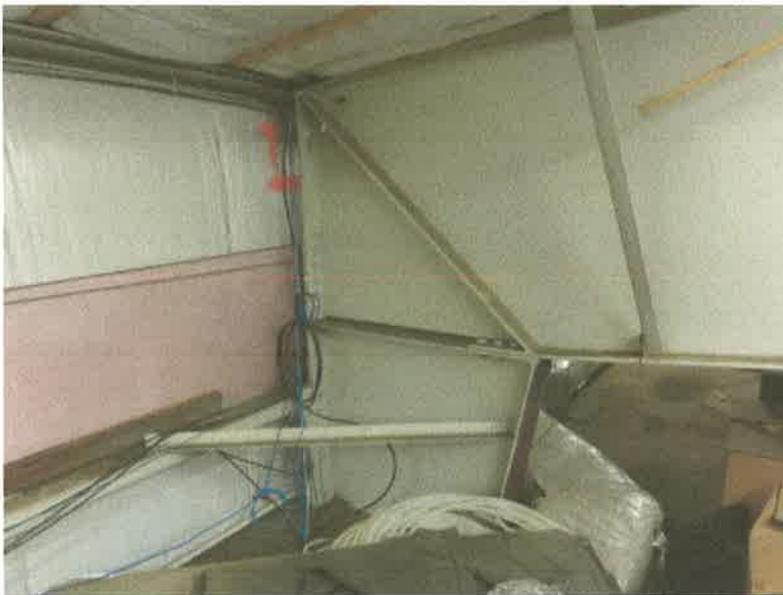
**Photo 11**

The connections between beams and columns of the bent are stiffened and braced by kickers.

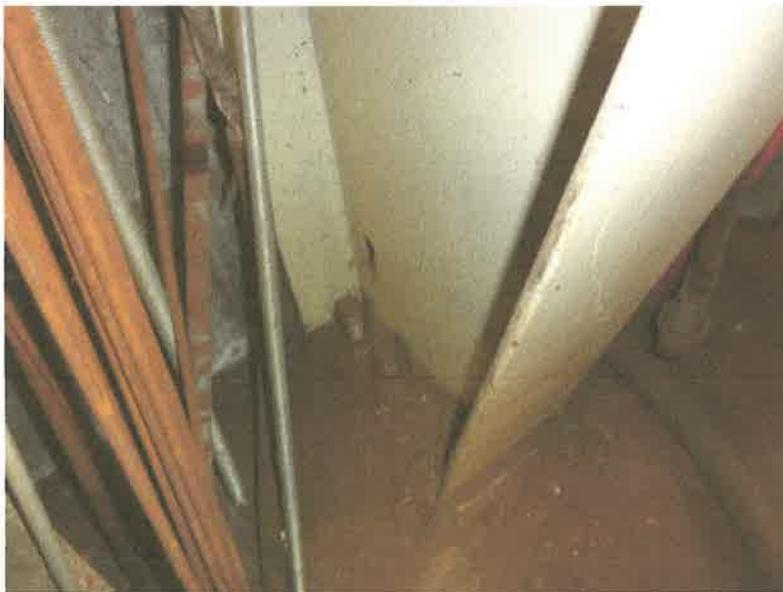
**Photo 12**

The base of the bents are anchored to the foundation by four closely spaced anchors.

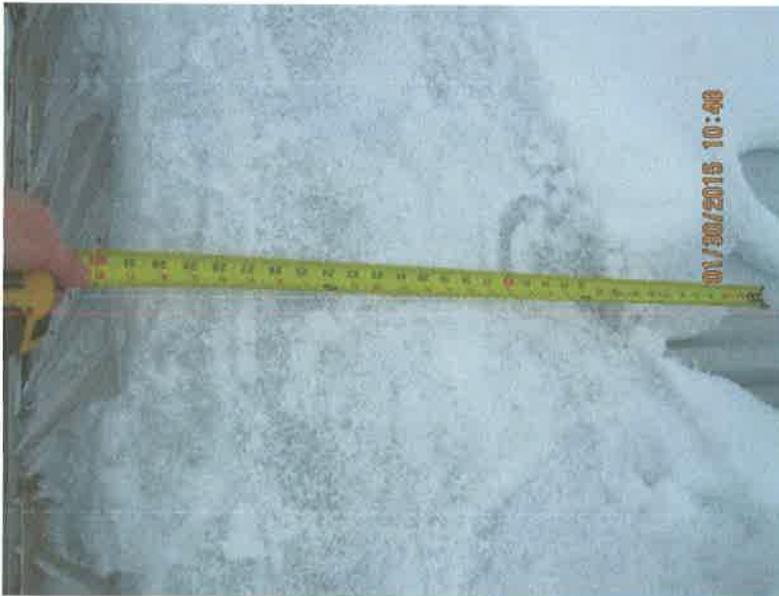
Photo 2

We visited the site on 30 January 2015 and observed ice dams (Photos 2 and 3) along both building eaves with icicles spanning and covering sections of the wall (Photo 4). We observed melting areas on the roof above purlins (Photo 5) and at areas in the field of the corrugated panels (Photo 6). We also observed ice and moisture on the interior of the corrugated metal panels at damaged insulation areas on the walls and the roof (Photo 7). We discussed our initial observations with you to determine the following investigation scope of work.

Ice dam at eave edge.

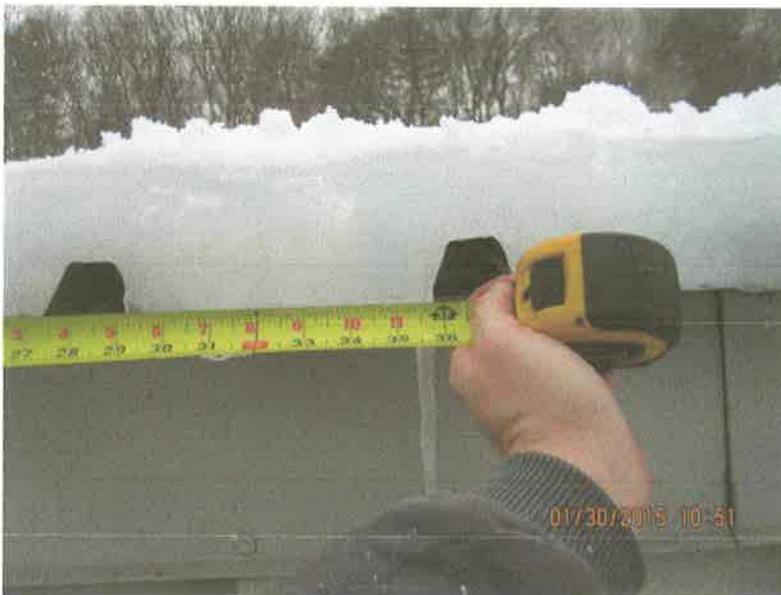
Photo 3

Ice dam at eave edge.

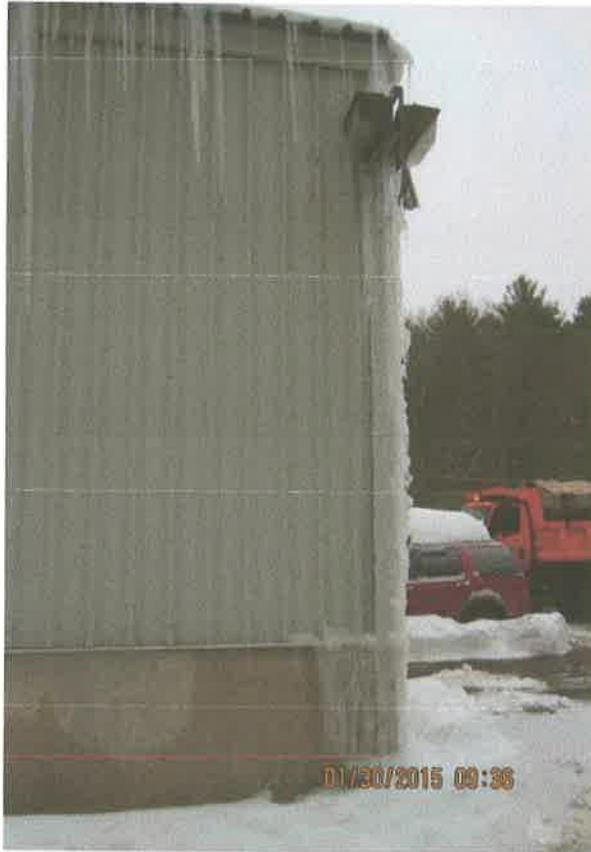
Photo 4

Ice dam transitions down face of wall.

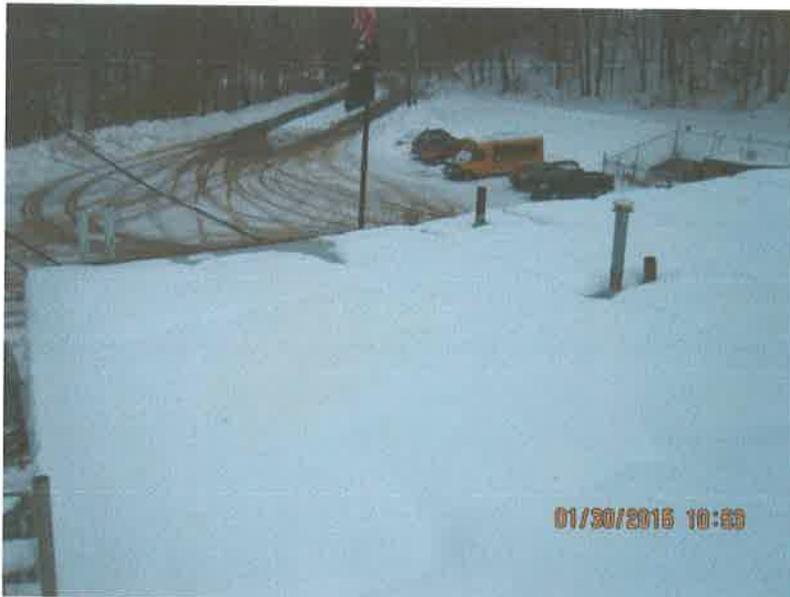
Photo 5

Snow melt above purlins.

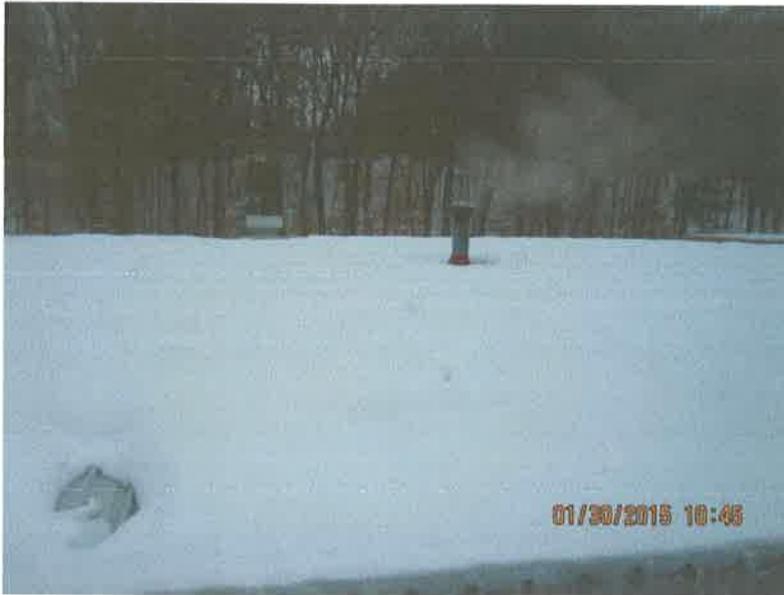
Photo 6

Snow melt adjacent to roof and wall transition.

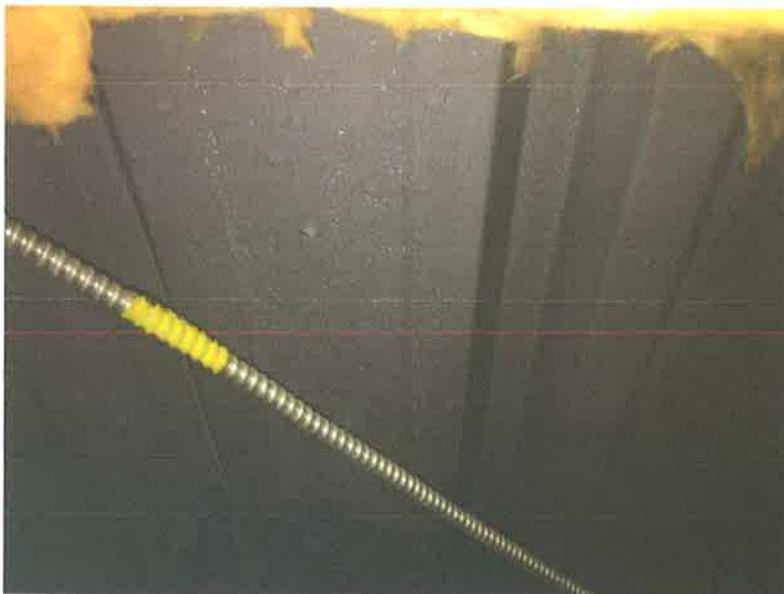
Photo 7

Condensation on the underside of the roof panel.

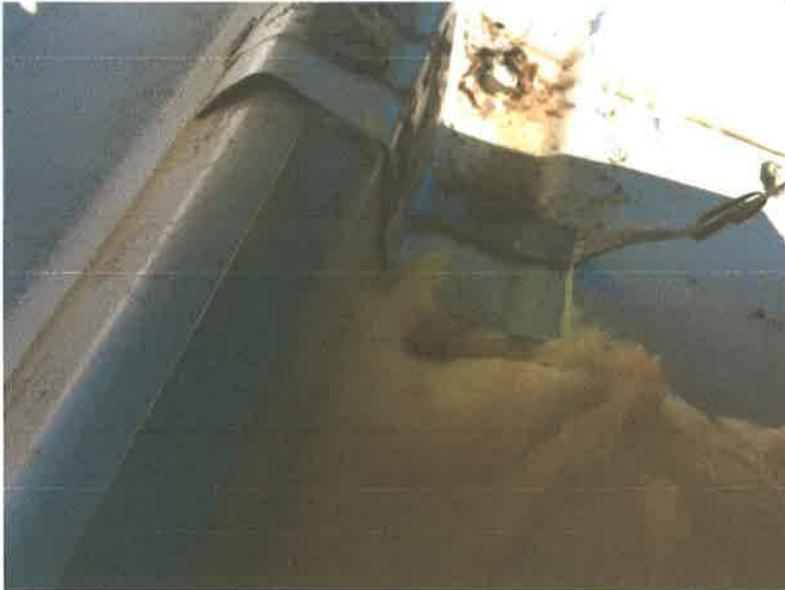
Photo 10

Butyl tape at vertical metal roof seam – not adhered.

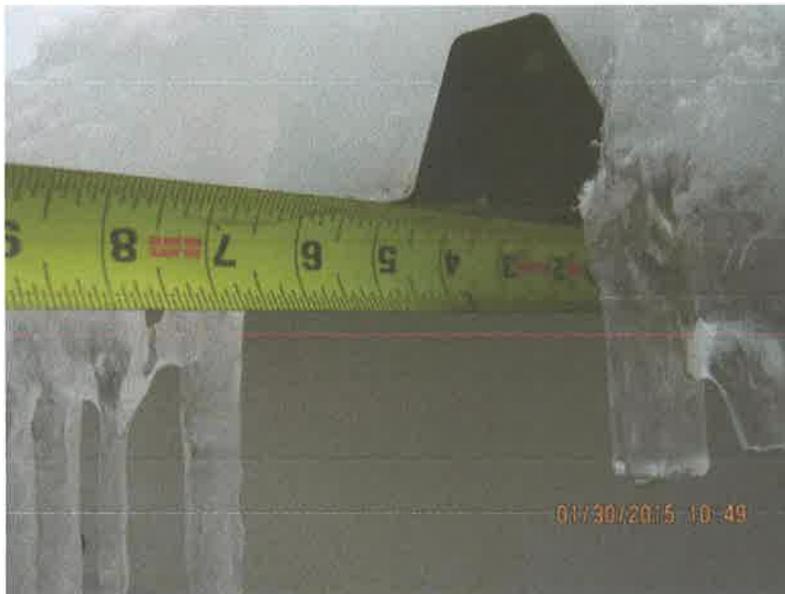
Photo 11

Butyl tape at transverse joint and vertical joint – not adhered.

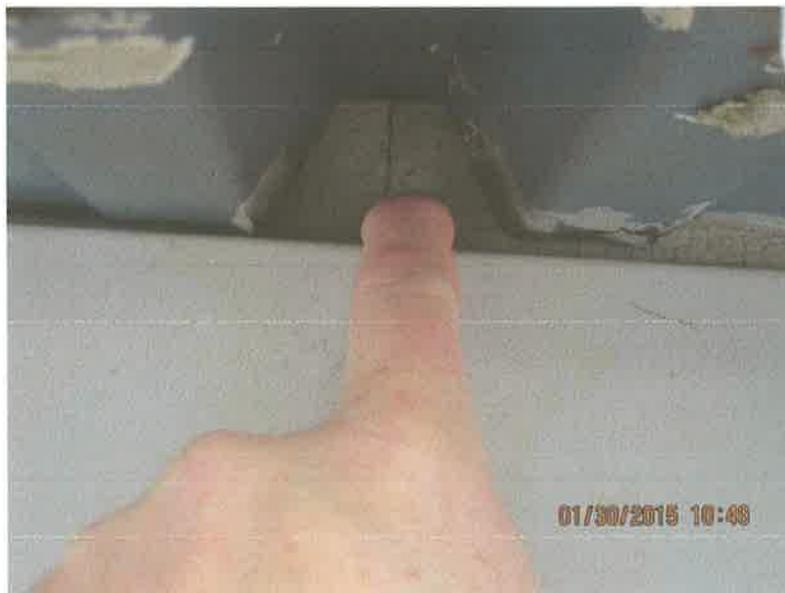
Photo 12

Corrugated roof panel overhang at the wall.

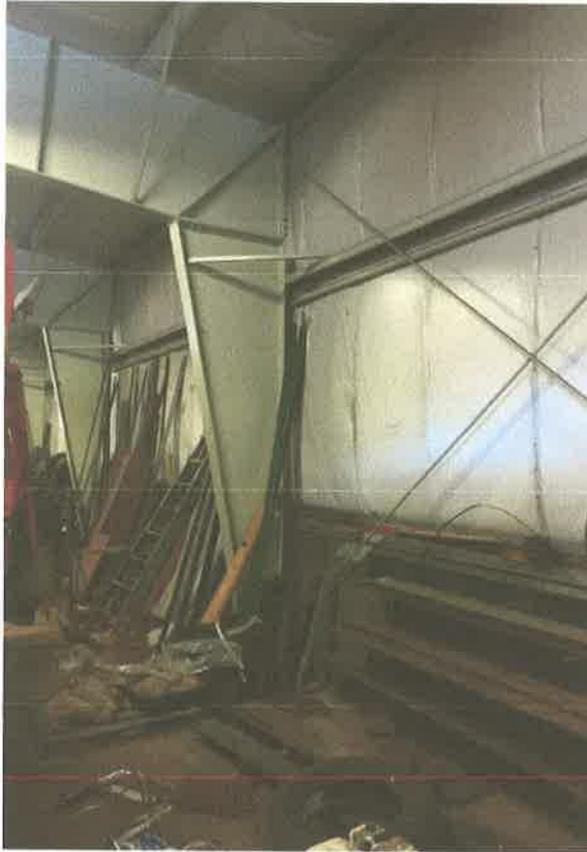
Photo 15

Vinyl faced batt insulation supported with wood strapping.

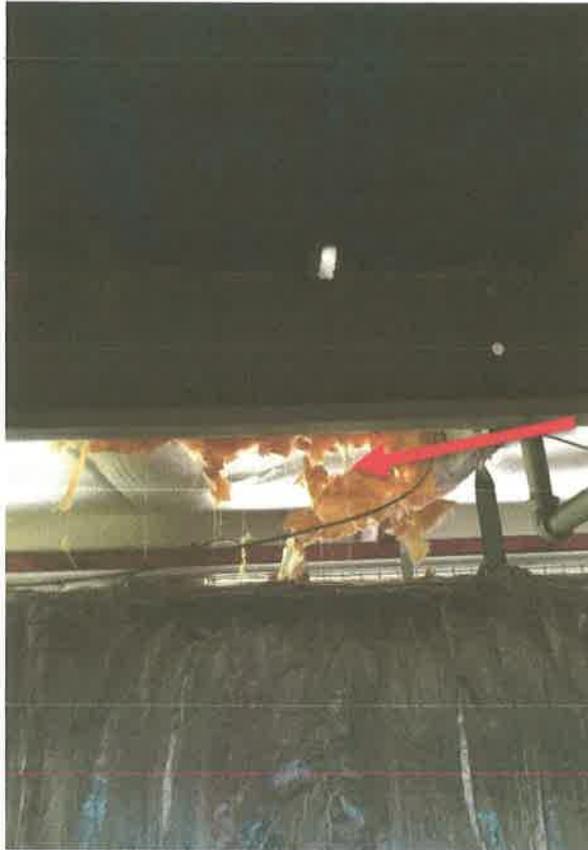
Photo 17

We made openings in the insulation mounted to the underside of the roof panels and inside face of the wall panels. We observed dripping condensation on the underside of the metal roof panels prior to water testing (Photo 17). We checked weather data and determined the last precipitation event prior to our 7 October 2015 investigation was a light mist that occurred early the morning of 6 October 2015.

Condensation on the underside of the corrugated metal roof panel.

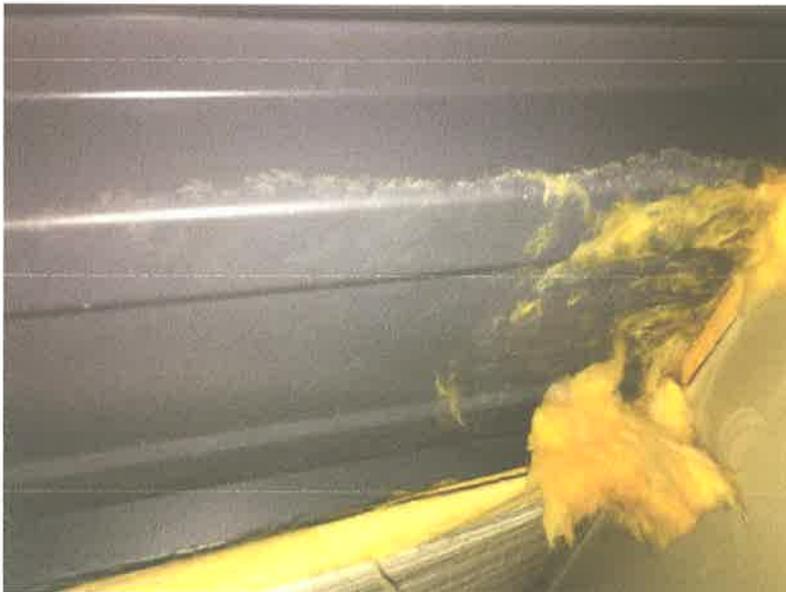
Photo 18

We performed a flood test of transverse and vertical seams in the metal roof panels to replicate probable conditions during ice dams. We created a pond of water over vertical and horizontal seams as well as over fastener locations. Water immediately leaked to the interior during our test (Photo 18).

Leak during flood test.

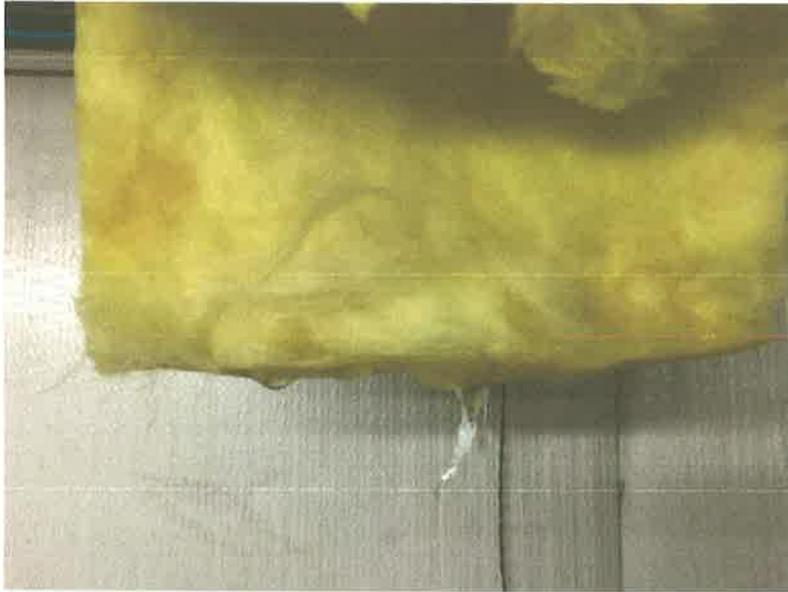
Photo 19

Ice on the underside of the roof insulation.

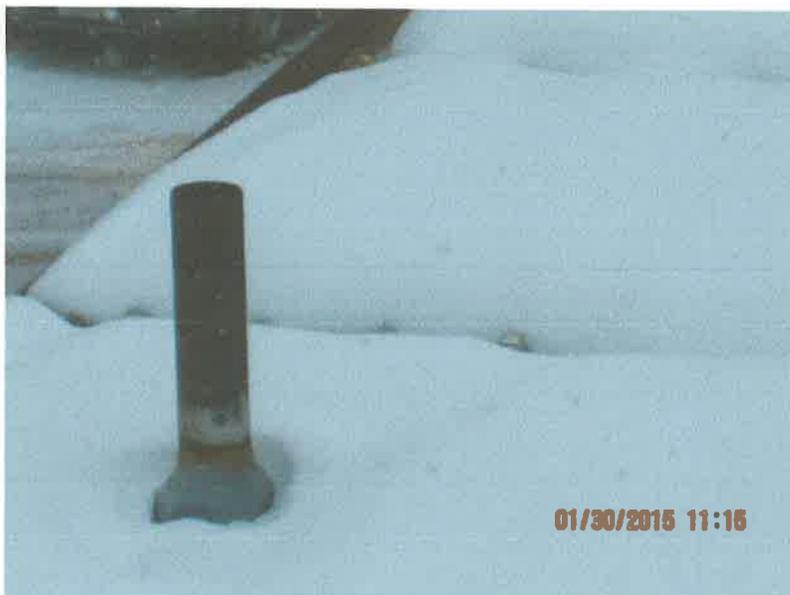
Photo 11

- The metal panels and insulation above and behind the damaged or open seam areas of insulation is wet and frozen (Photo 10).
- Daylight is visible at the roof-to-wall intersection in multiple areas (Photo 11).
- Equipment and tools leaning on the wall insulation causing damage to the vinyl insulation liner.

Daylight visible at wall-to-roof transition.

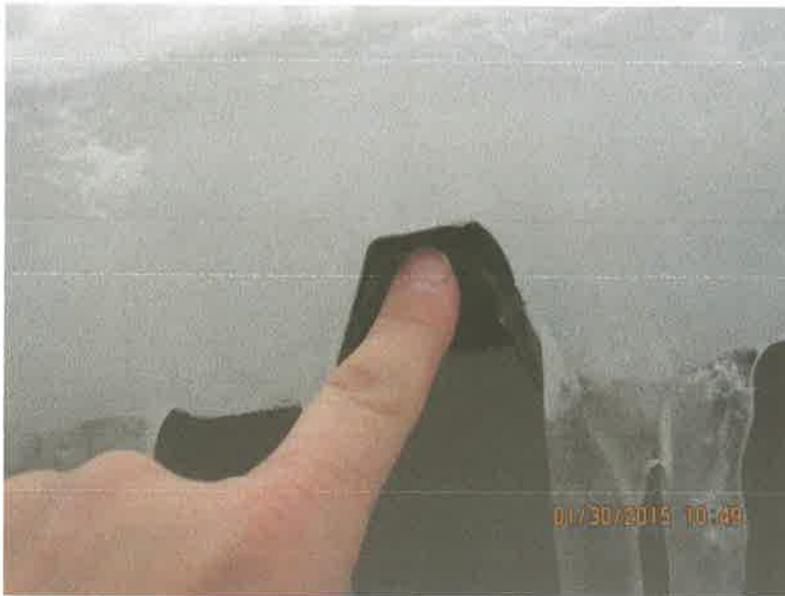
Photo 12

- The roof is face-fastened overlapping corrugated metal sheets with a transverse joint at the roof slope midpoint. The eave channels are closed with foam insulation (Photos 12 – 14).

Transverse lap in corrugated metal roofing.

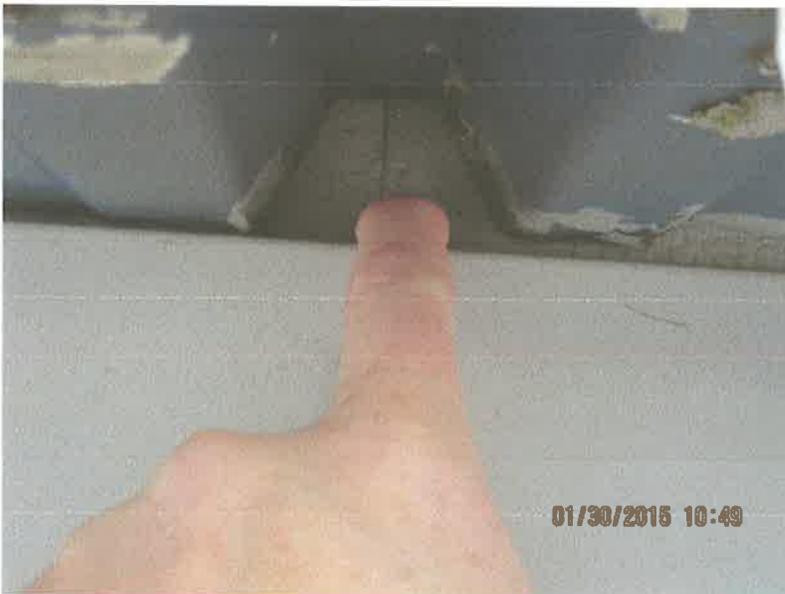
Photo 13

Corrugated metal roofing lap.

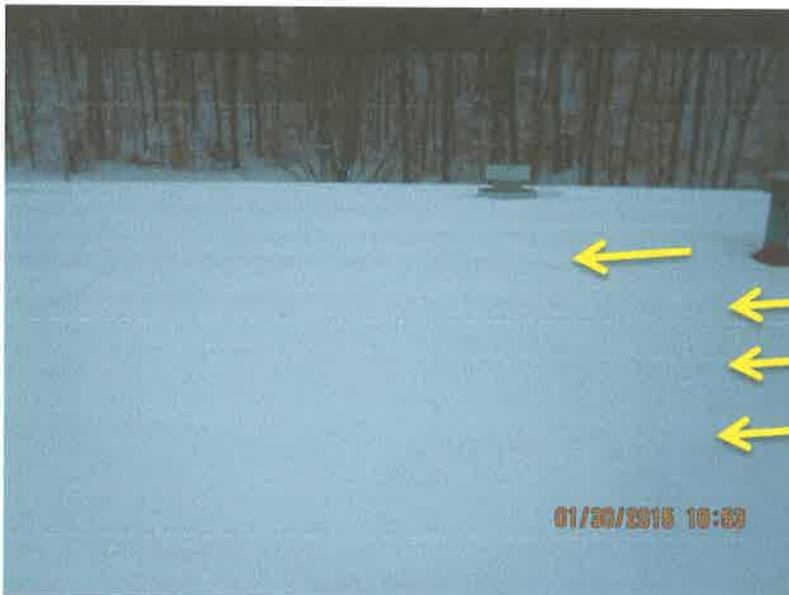
Photo 17

- Ice dams are approximately 2 in. thick and extend 2 ft or more from the roof eave toward the roof ridge (Photo 17).
- The internal purlins transmit heat through the roof, and their locations are visible from melted areas of snow (Photo 18).

Ice dam at eave edge.
